#### SUPPLEMENTAL EXPANDED SITE INVESTIGATION REPORT

## OLD DELAWARE CITY LANDFILL Delaware County, Ohio

May 20, 2009

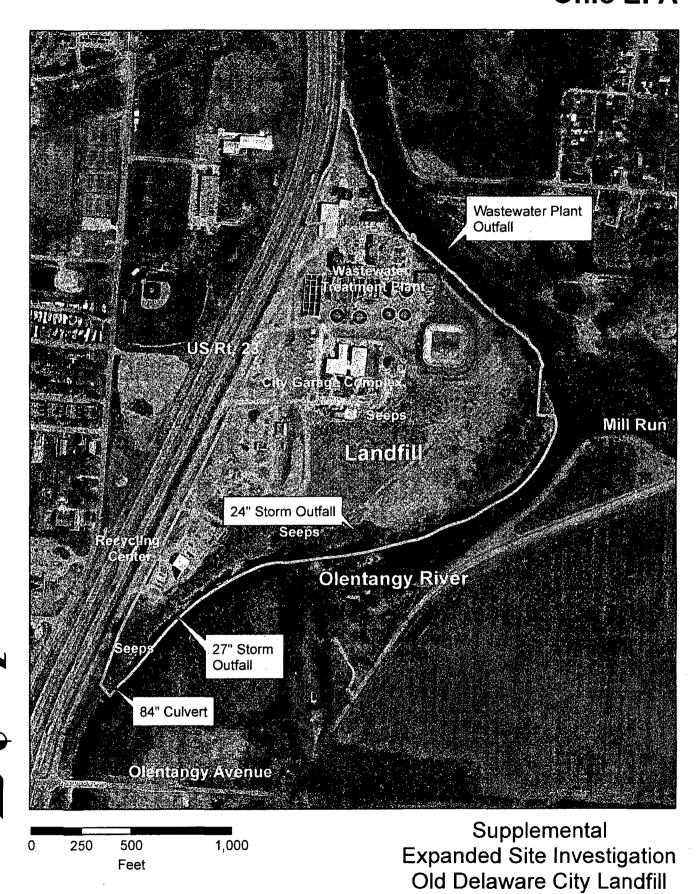
Figure 2

The Old Delaware City Landfill, also known as the Cherry Street Landfill, is located on property owned by the city of Delaware north of Olentangy Street between U.S. Route 23 and the Olentangy River. The site location is displayed on **Figure 1**. In addition to the landfill, the city-owned property is occupied by the municipal wastewater treatment plant, maintenance garage, salt sheds and recycling center. The footprint of the original landfill has changed due to periodic waste removal and relocations to allow for expansion of the wastewater treatment plant. The area of waste placement was determined to be approximately 33.4 acres according to a waste delineation survey conducted in 2000 (Malcolm Pirnie). The most recent waste relocation occurred in 2003. The site features are displayed on **Figure 2**.

Site Features

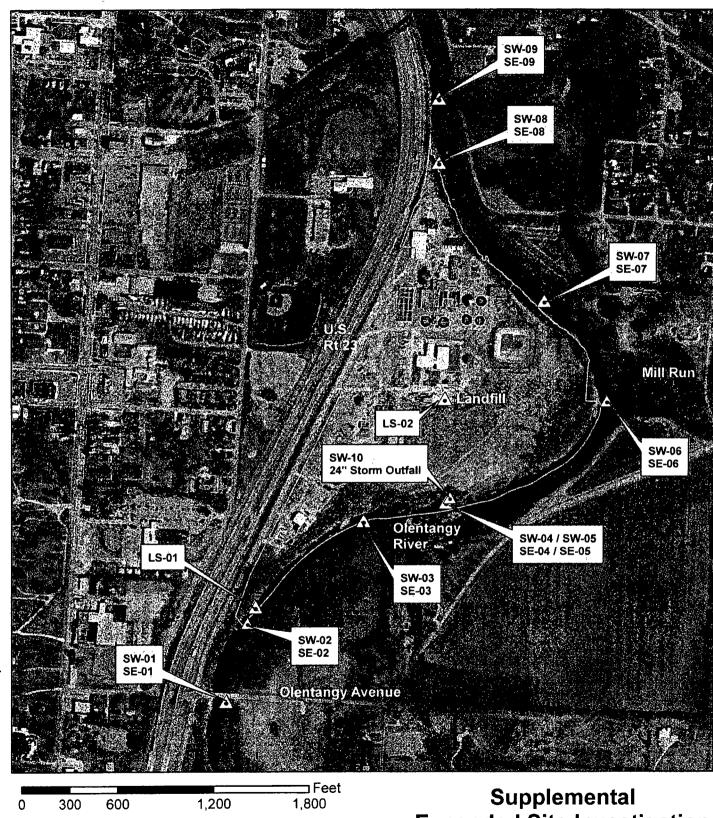
Sample locations are displayed on **Figure 4** and are described below. Site location photographs are included in **Appendix C**.

Expanded Site Investigation
Old Delaware City Landfill
Sample Location Map
